## Air-Vent Exteriors GHRC-100

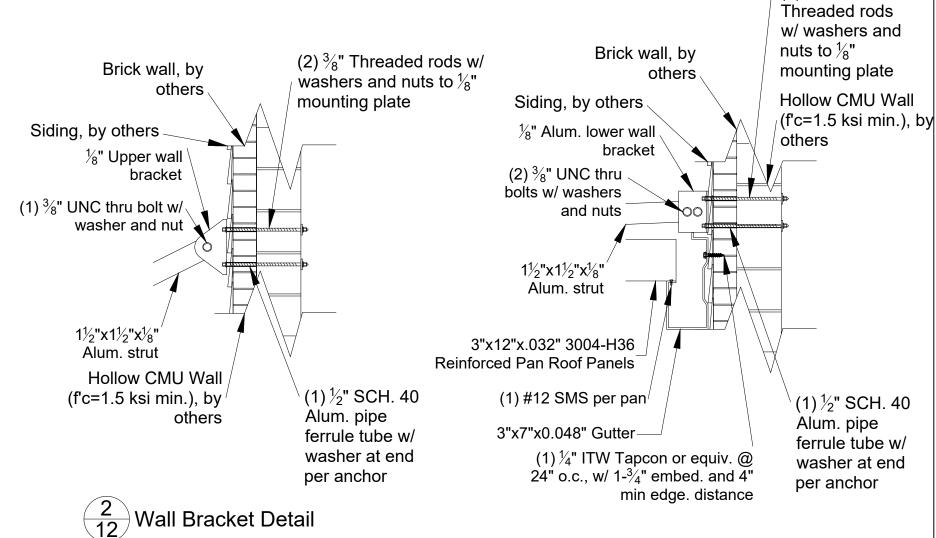
Rear Gutter Detail

$(2)\frac{3}{8}$ "

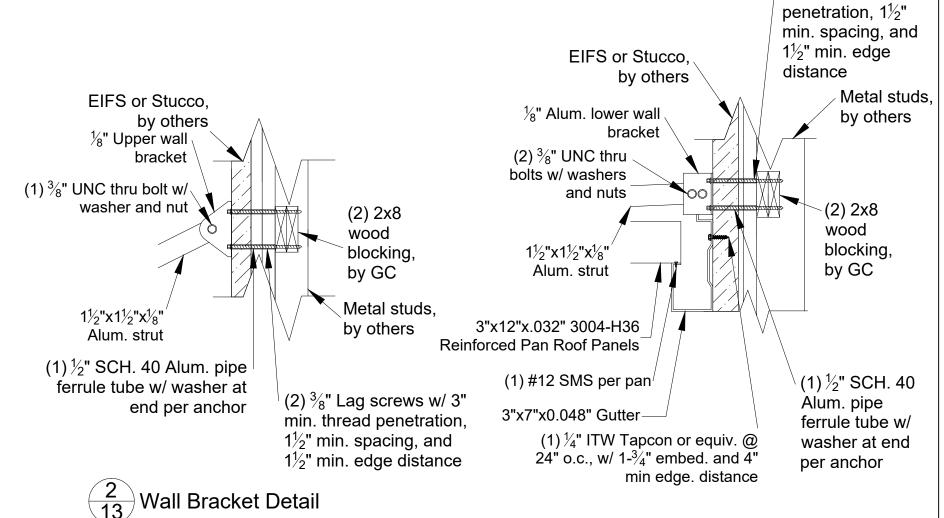
Rear Gutter Detail

(2)  $\frac{3}{8}$ " Lag screws w/ 3" min. thread
